California's Abandoned Mine Lands Program Fact Sheet Abandoned Mine Inventory and Remediation

Field Inventories

Remediations

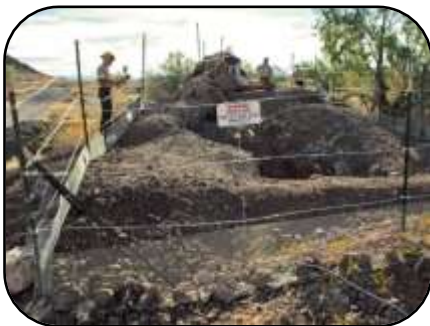
Fence, Imperial Co.

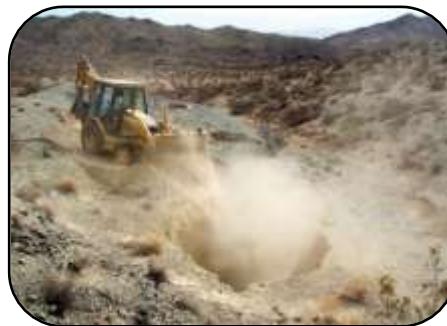
Backfill, San Bernardino Co.

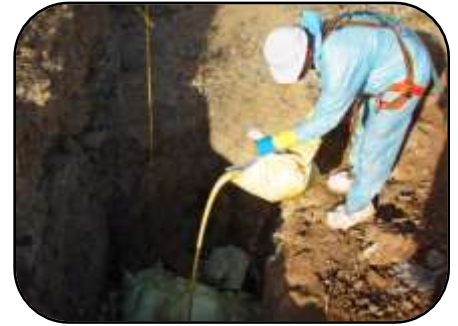
PUF closure in progress, Inyo Co.

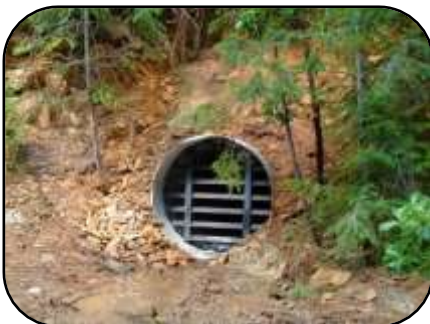
Culvert gate, El Dorado Co.

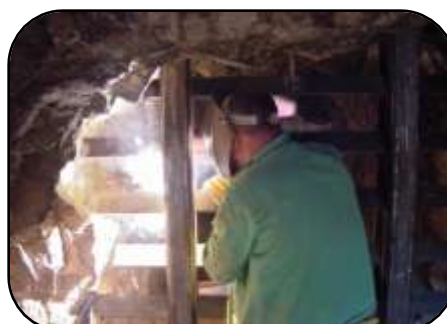
Bat gate in progress, Riverside Co.

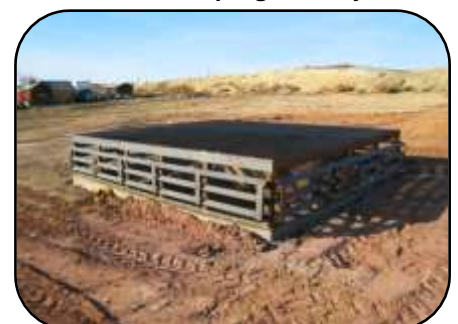
Bat cupola, Kern Co.
